Exhibit 2: Current Condition Site Images

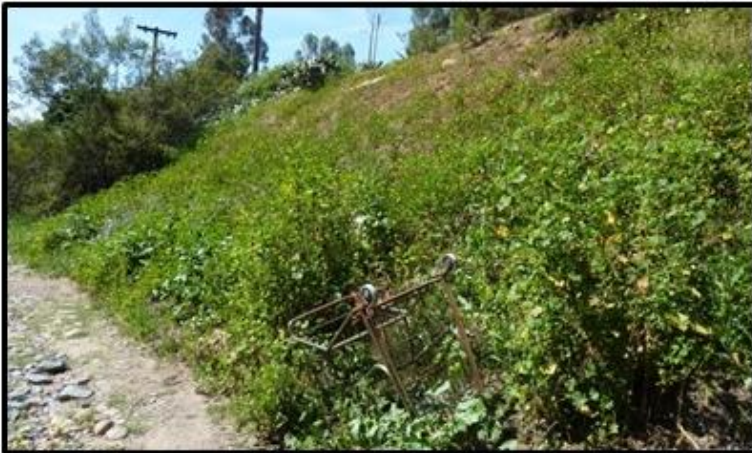
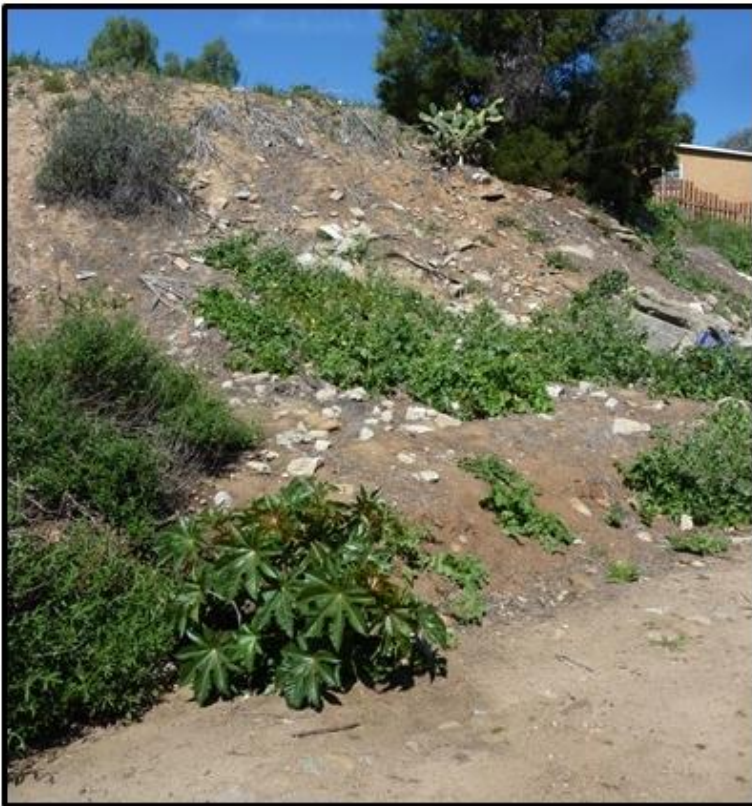
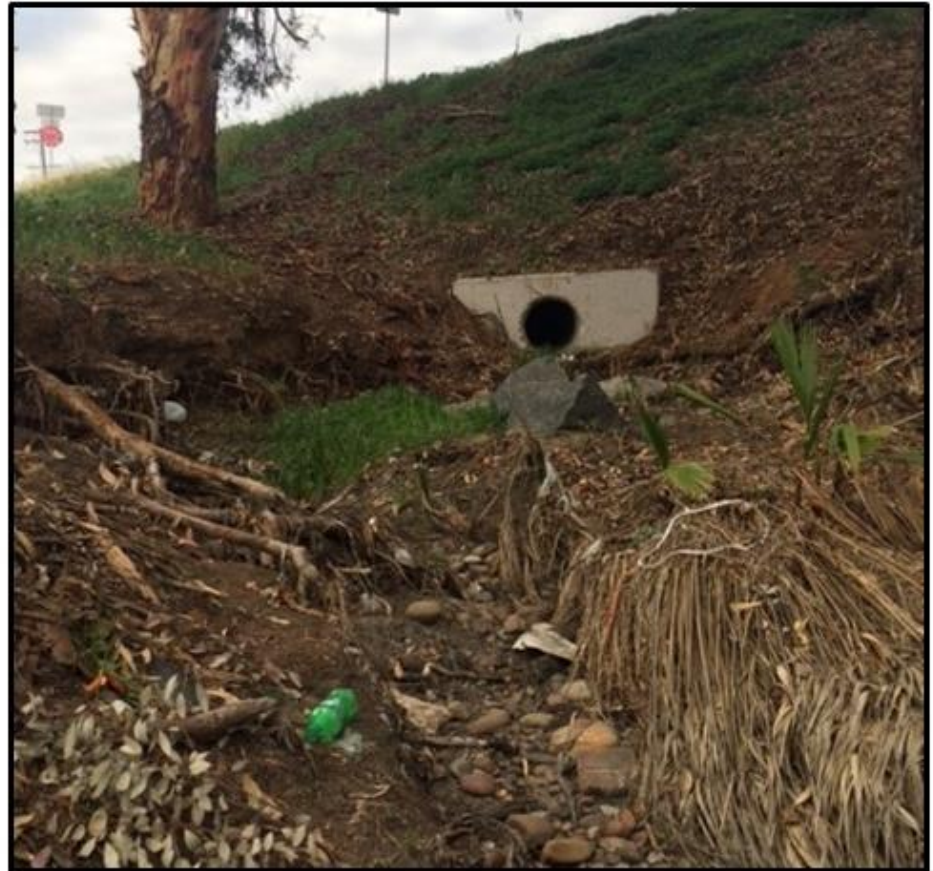
Photos 1, 2, & 3. Manzanita Canyon is blighted with introduced plants; degraded, un-vegetated, slopes; trash accumulations and illegal dumping; and large volumes of storm water runoff from the surrounding streets. The above photo shows the storm drain outfall from the Triangle Property into the Manzanita Canyon streambed.

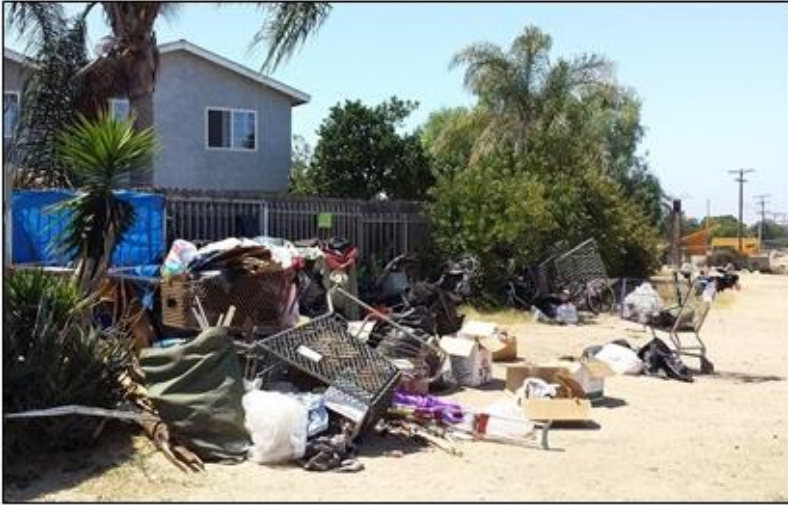
Photo 4. Homeless encampments are common within the Triangle Property. The Living Lab (yellow building) is in the background.

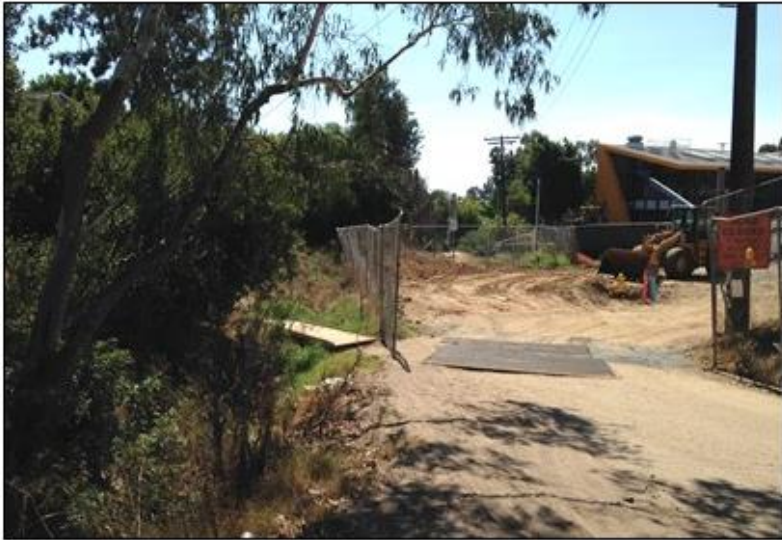
Photo 5. The intersection of Thorn St. (potential site of Green Street infrastructure) with the canyon streambed (left) and Living Lab (background).

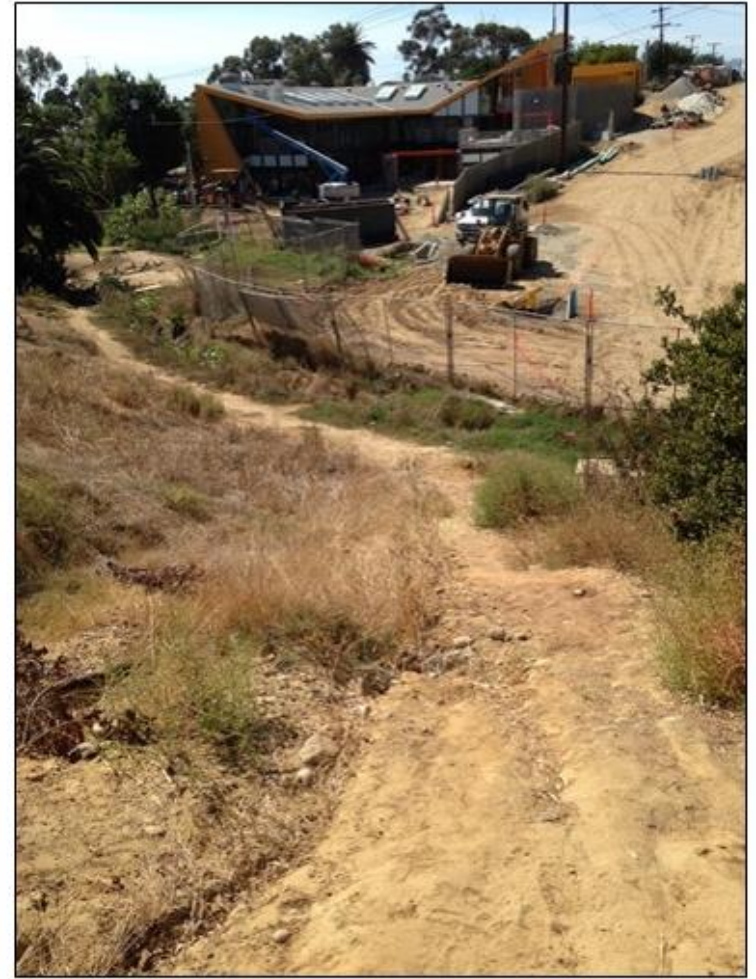
Photo 6. The current steep, eroded, and hazardous social trail from the top of the Triangle Property down to the Living Lab and canyon entrance.
